**U.S. EPA REGION VIII
TECHNICAL ENFORCEMENT PROGRAM
RCRA COMPLIANCE EVALUATION INSPECTION REPORT**

Facility: Frontier Refining, Inc.
2700 East 5th Street
Cheyenne, WY 82007

Inspection Type: Corrective Action Compliance Inspection
For Pond 2 Clean-Out

Date: October 31, 2011

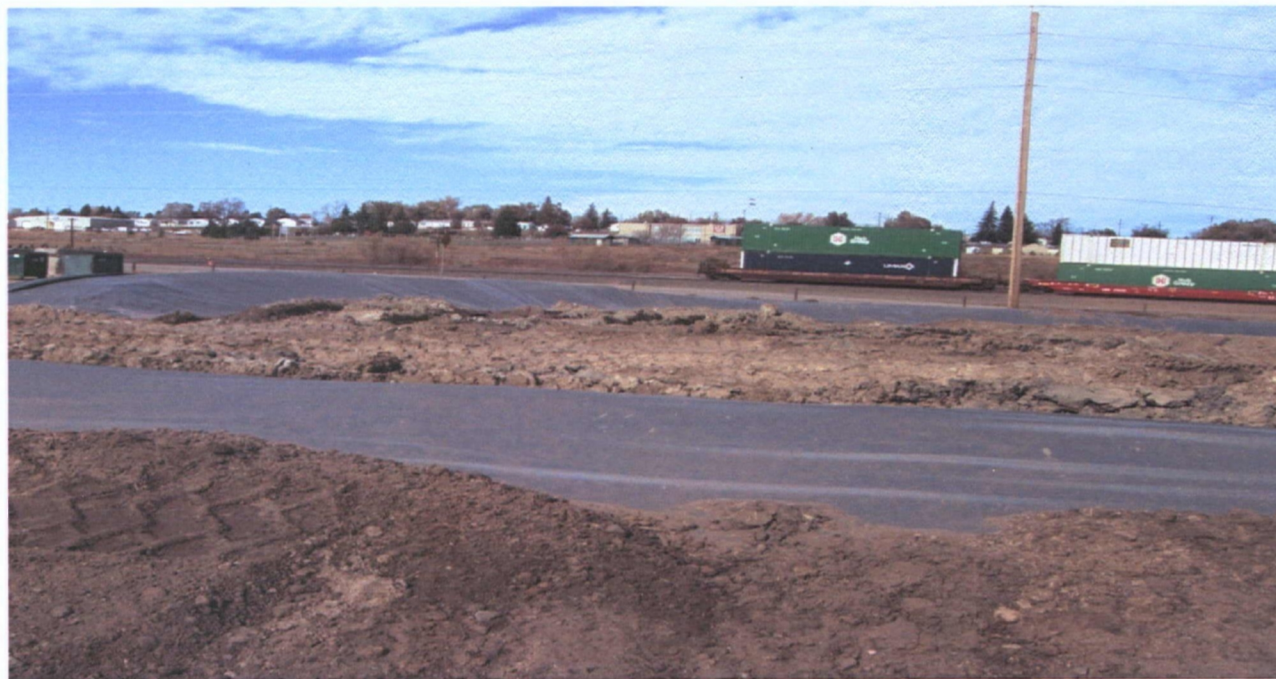
Photo: 1
Facility: Frontier Refining
Subject: Storage Pad for Clay
Removed from Pond 2
Photographer: Linda Jacobson
Date: October 31, 2011

After a lunch break, Mr. Denton drove Ms. Jacobson to the site of the three pads used for storage of removed clay and soils from Pond 2. Two of the pads were empty except for recent precipitation. The snowmelt in the pads was to be removed and treated in the onsite wastewater treatment plant. One of the pads contained approximately 300 cubic yards of contaminated clay scraped from the surface of the clay layer. Mr. Denton stated that the facility planned to collect one composite sample of the clay for analysis for hazardous waste determination.

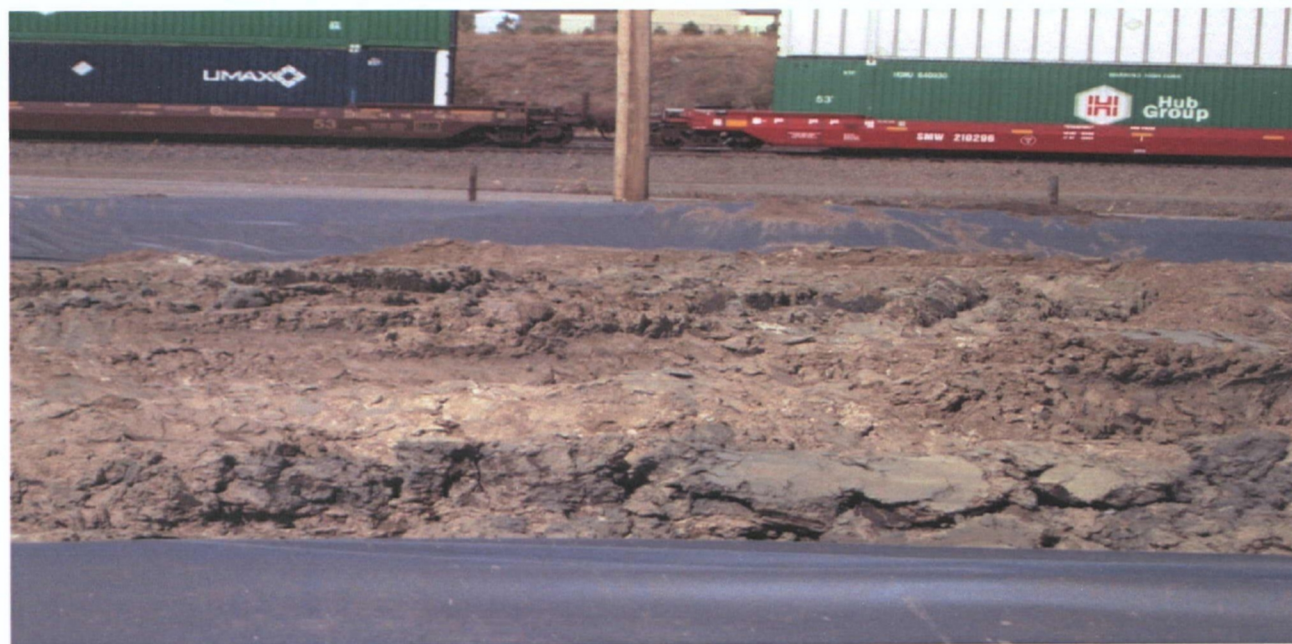
Photo: 2
Facility: Frontier Refining
Subject: Stained Clay Removed
from Pond 2
Photographer: Linda Jacobson
Date: October 31, 2011

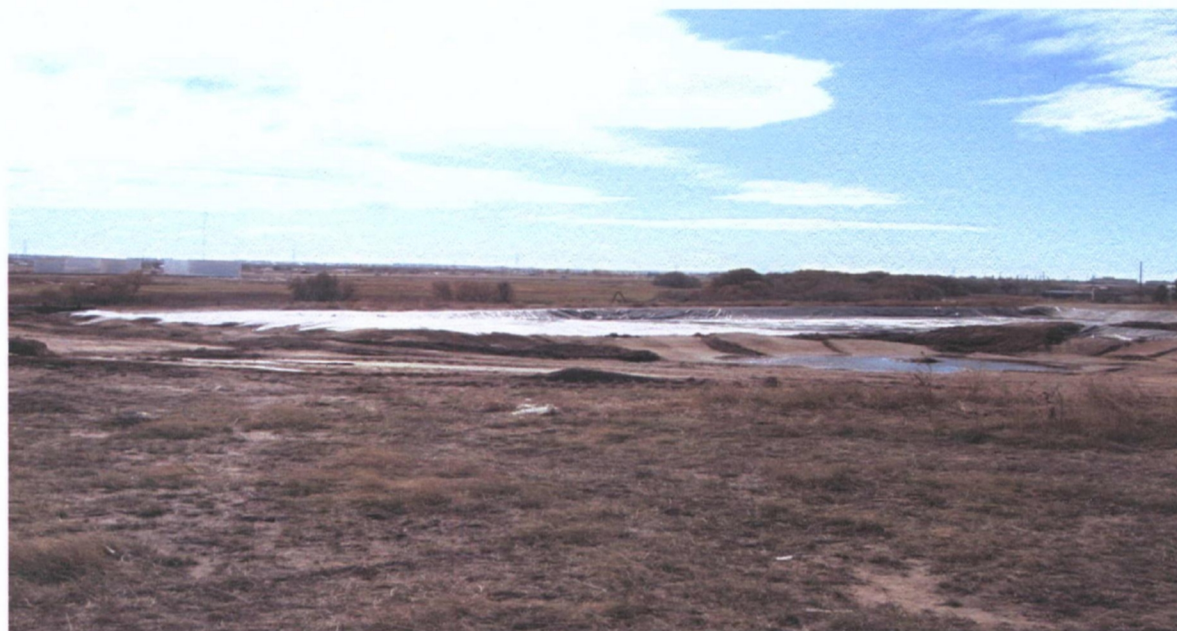
Photo: 3
Facility: Frontier Refining
Subject: Lined Pads Constructed
for Storage of Clay and Soils
Removed from Pond 2
Photographer: Linda Jacobson
Date: October 31, 2011

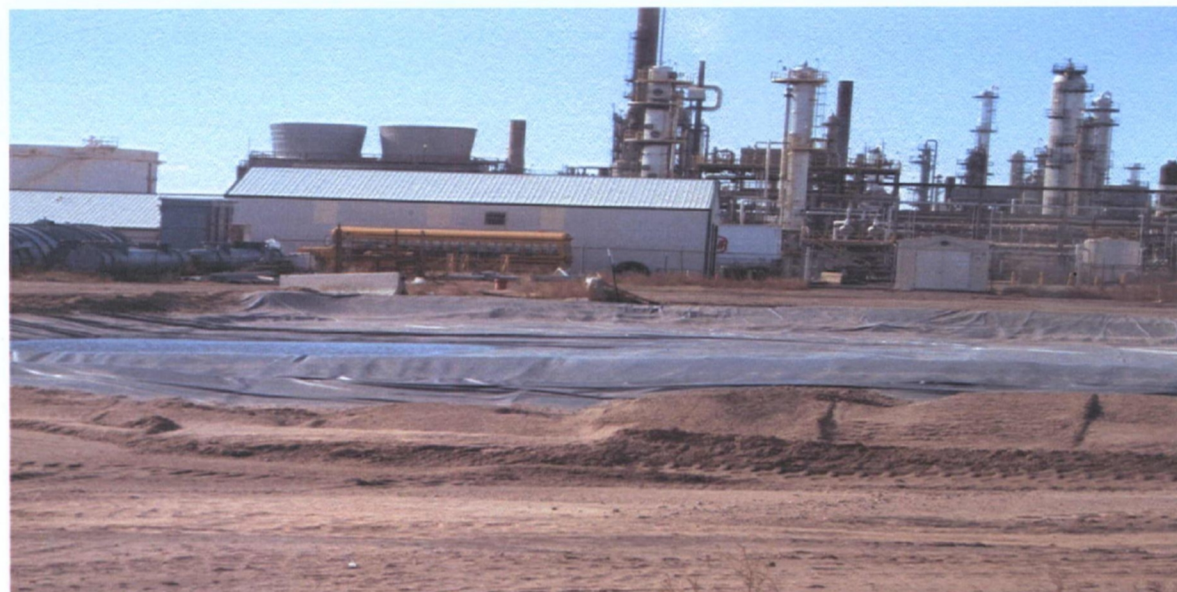
Photo: 4
Facility: Frontier Refining
Subject: Lined Storage Pad for
Materials Removed from Pond 2
Photographer: Linda Jacobson
Date: October 31, 2011

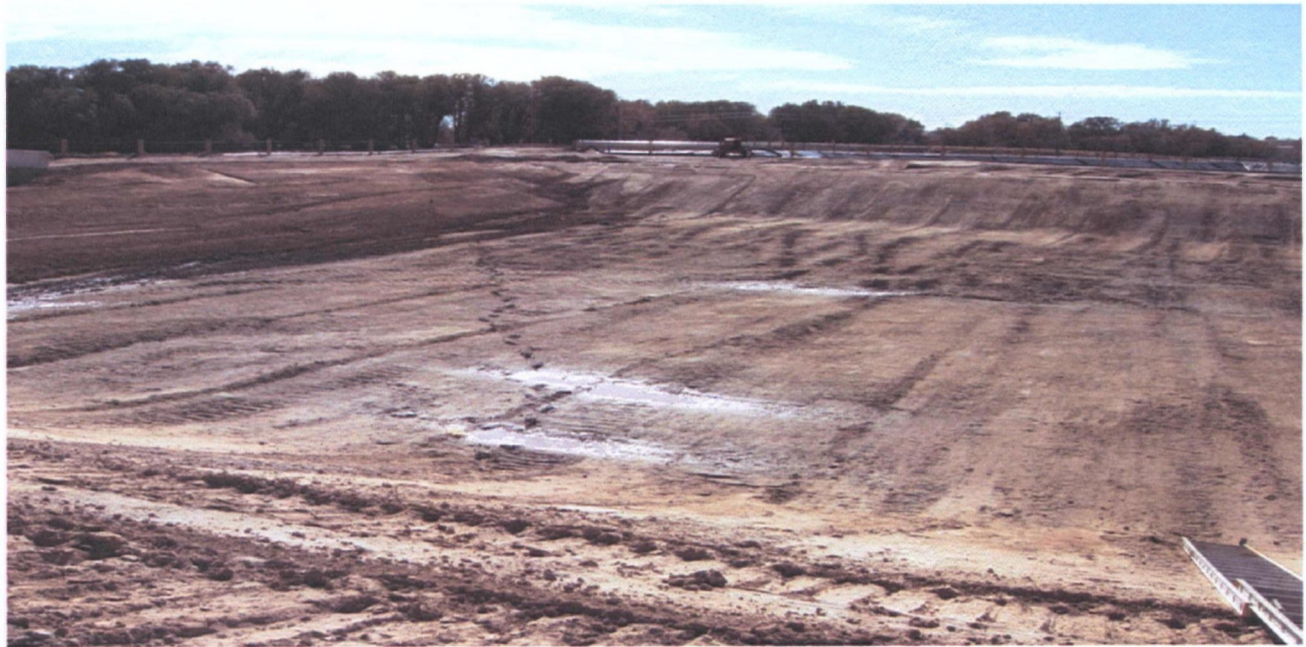
Photo: 5
Facility: Frontier Refining
Subject: Status of Clay Liner
Photographer: Linda Jacobson
Date: October 31, 2011

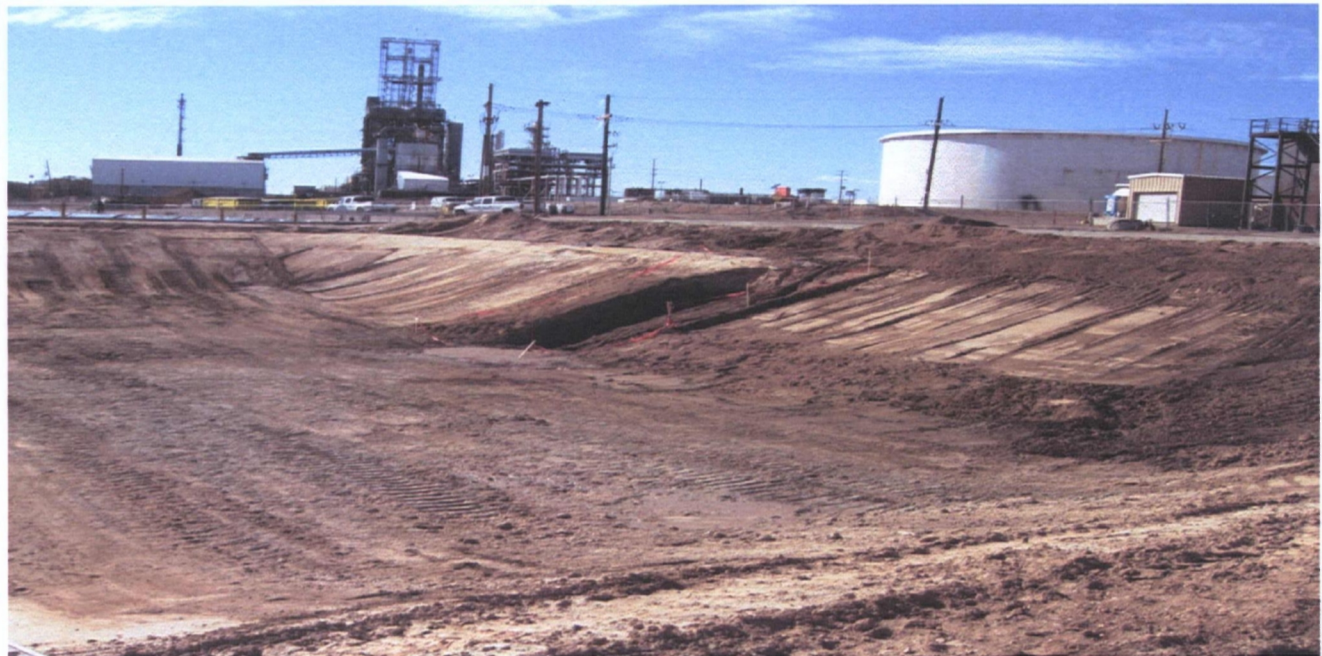
Photo: 6
Facility: Frontier Refining
Subject: Clay Liner after Removal of Synthetic Liner
Photographer: Linda Jacobson
Date: October 31, 2011

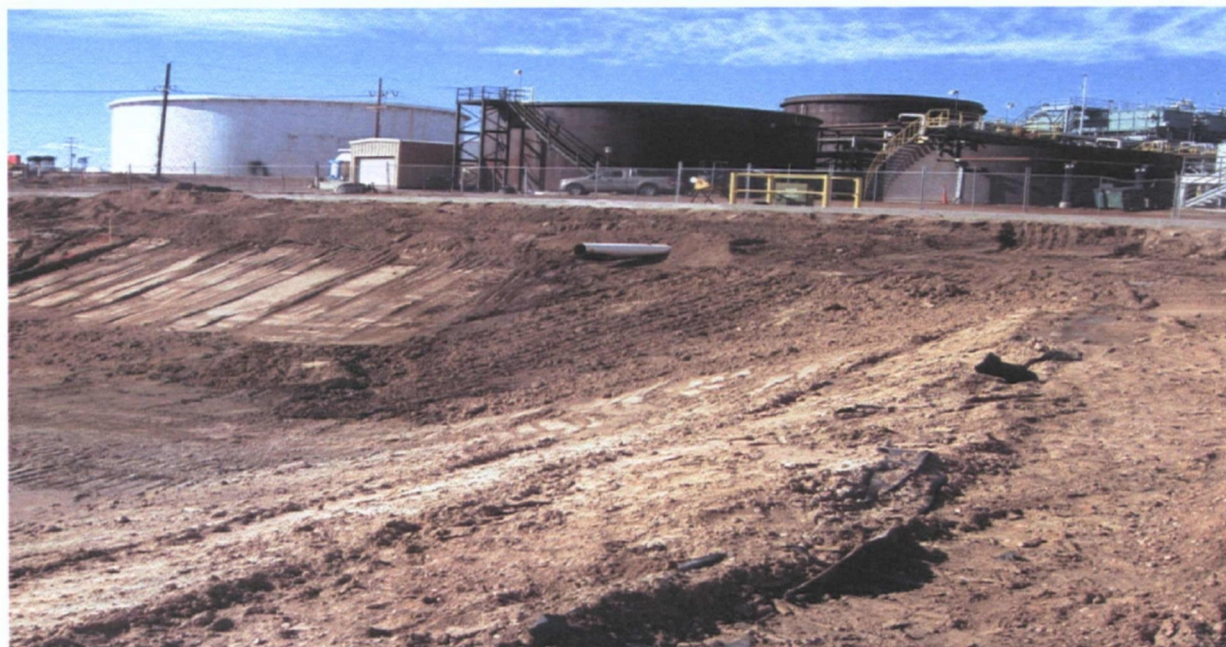
Photo: 7
Facility: Frontier Refining
Subject: Exposed Clay Liner and
Synthetic Liner Remnants to Be
Left in Place
Photographer: Linda Jacobson
Date: October 31, 2011

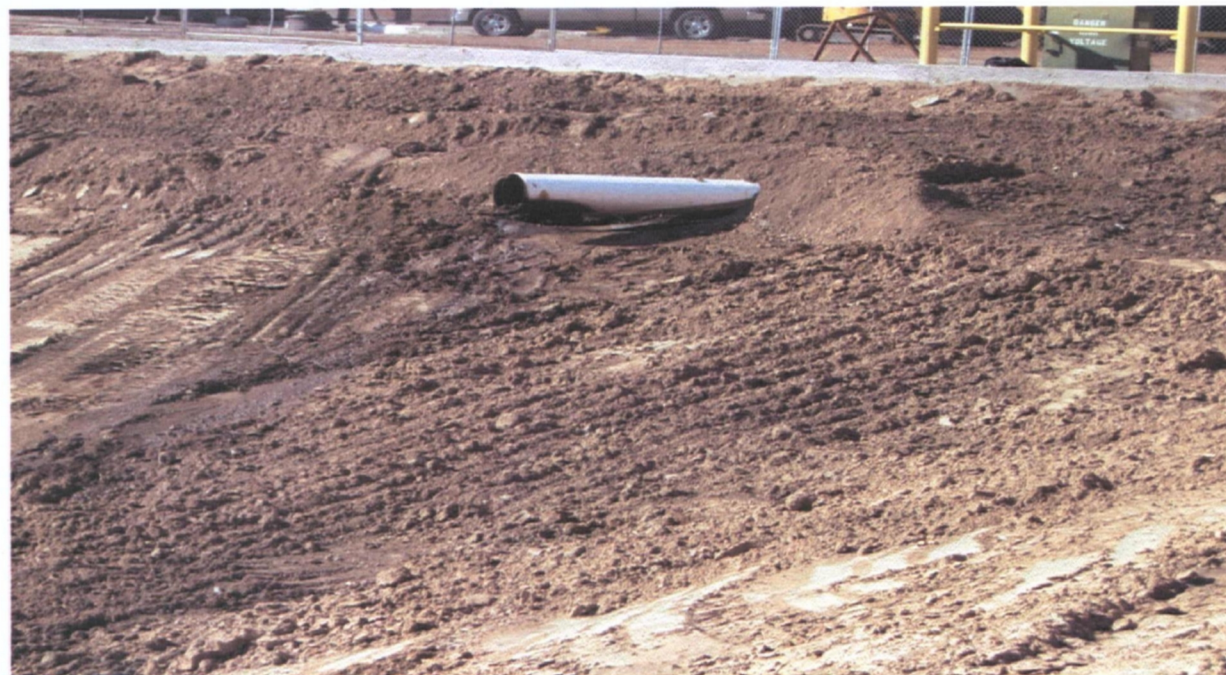
Photo: 8
Facility: Frontier Refining
Subject: Clay Liner in Pond 2
Photographer: Linda Jacobson
Date: October 31, 2011

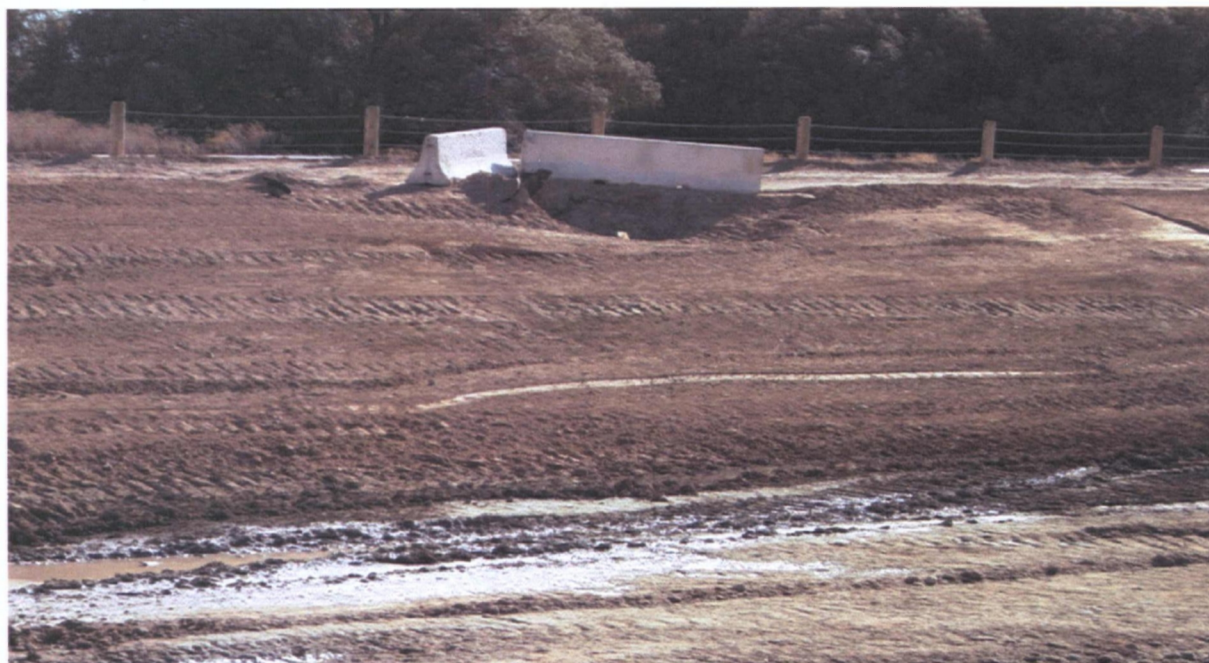
Photo: 9
Facility: Frontier Refining
Subject: Location of Former
Concrete Outfall
Photographer: Linda Jacobson
Date: October 31, 2011

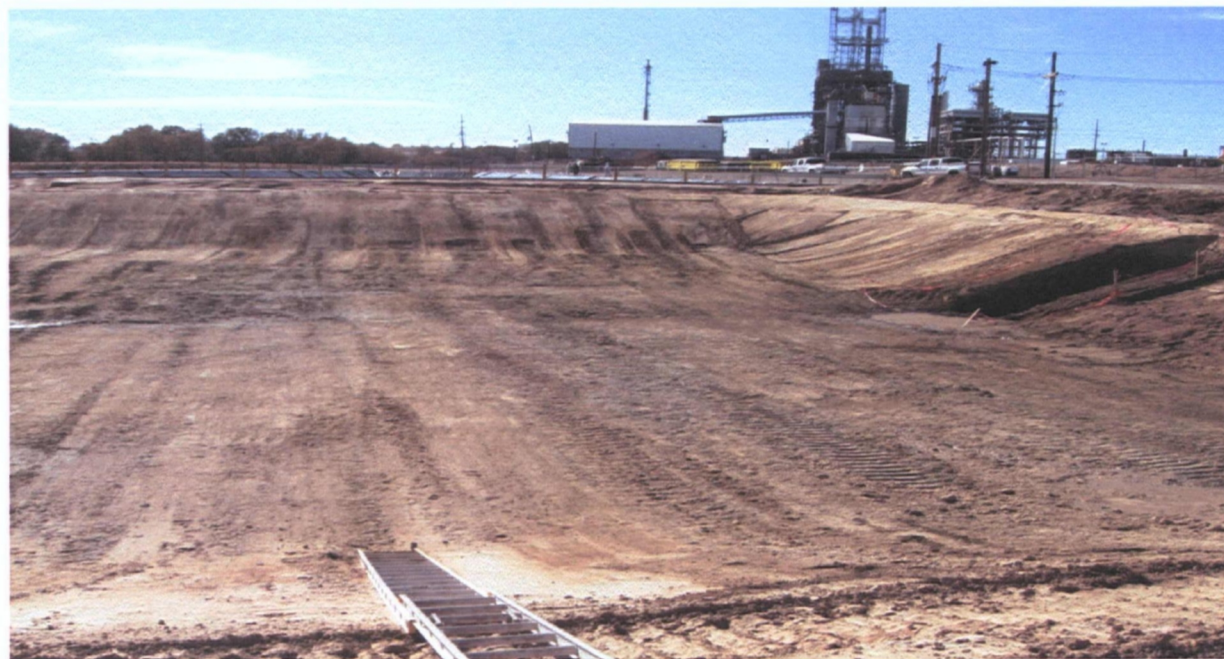
Photo: 10
Facility: Frontier Refining
Subject: Pond 2 Status with
Synthetic Liner Removed
Photographer: Linda Jacobson
Date: October 17, 2011

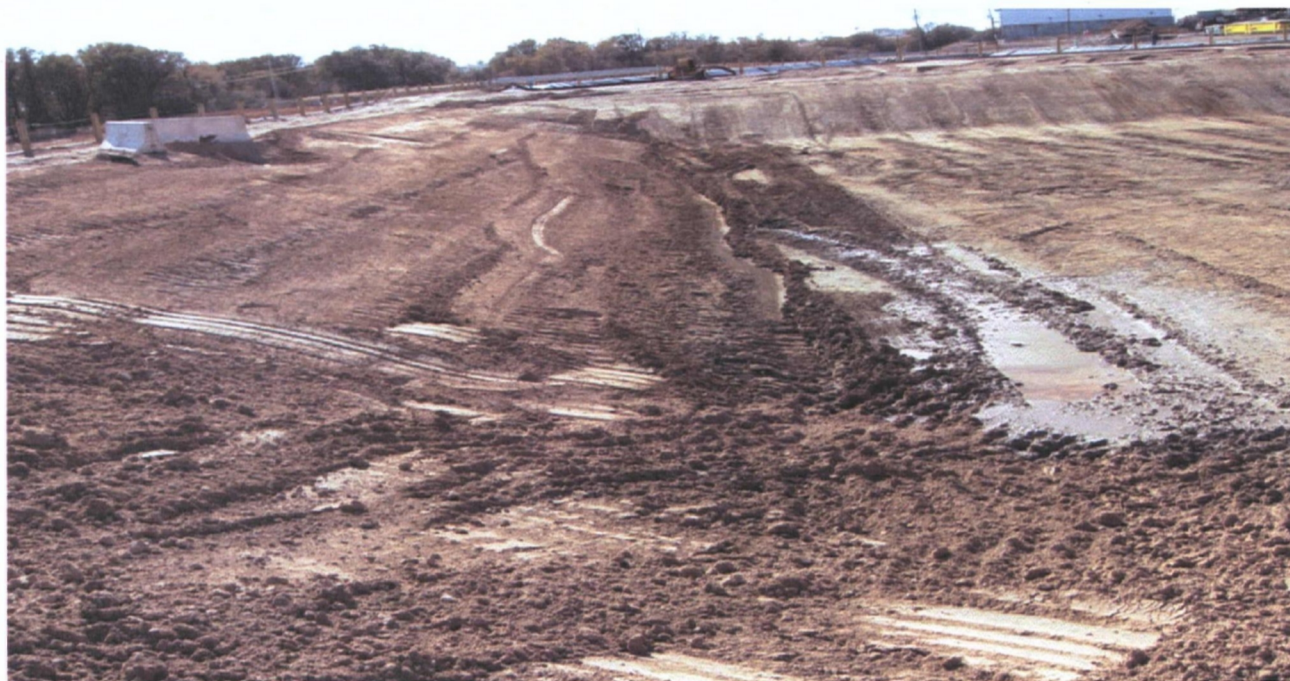
Photo: 11

**Subject: Clay Liner with Minute
Ponding from Recent Precipitation**

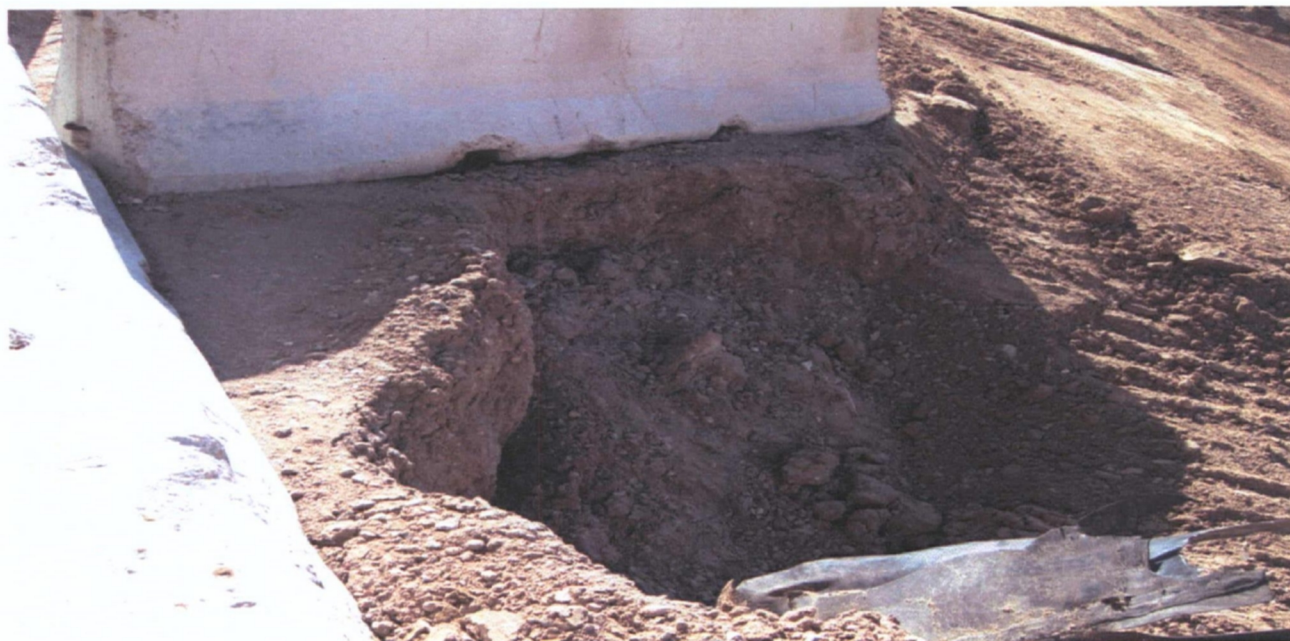
Photo: 12

Subject: Former Outfall Area

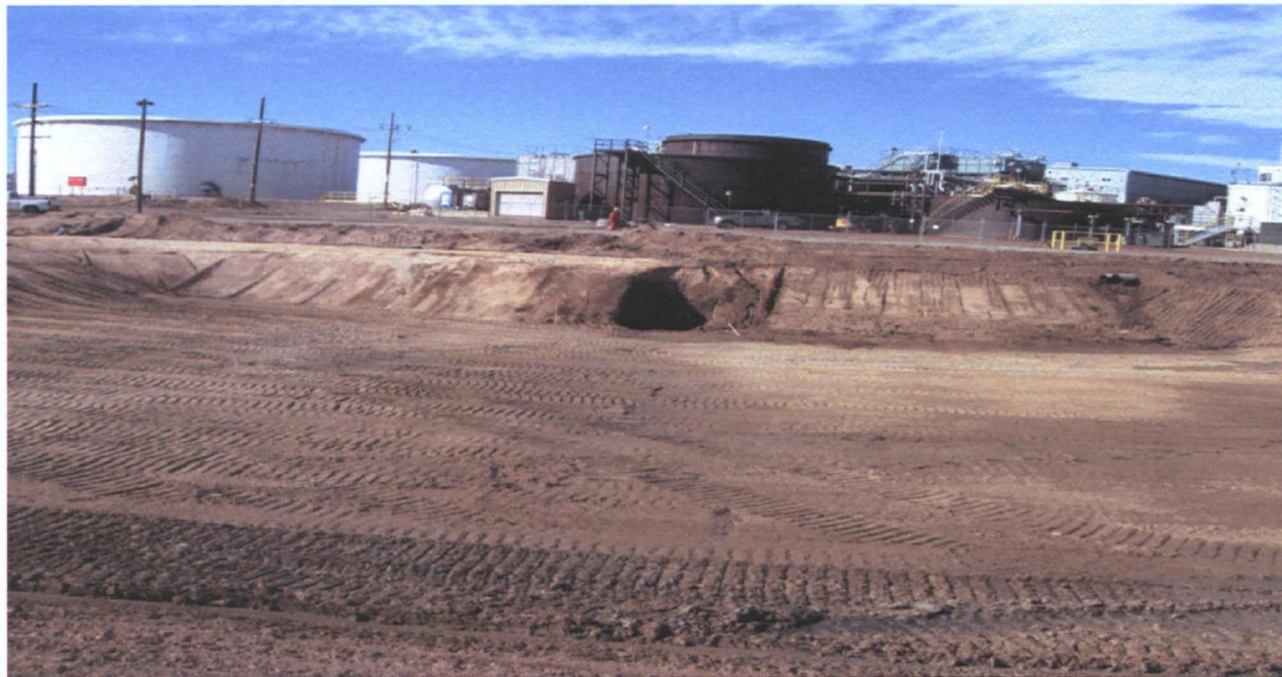
Photo: 13
Facility: Frontier Refining
Subject: Clay Liner
Photographer: Linda Jacobson
Date: October 31, 2011

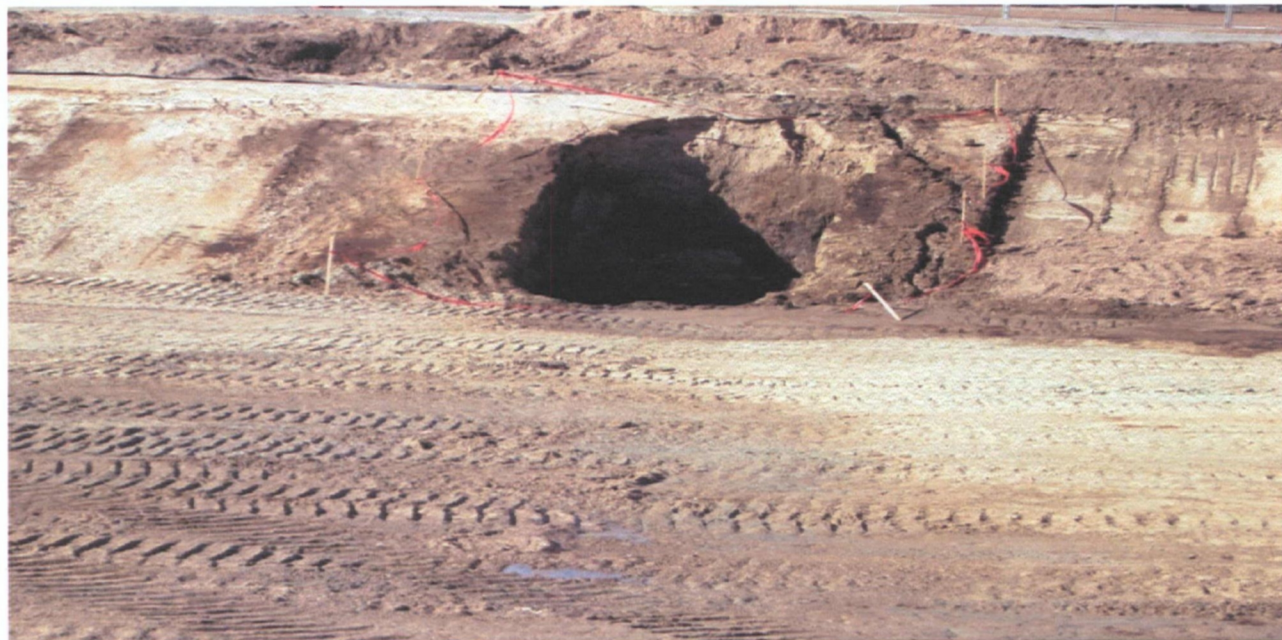
Photo: 14
Facility: Frontier Refining
Subject: Clay Liner Around
Former Walkway
Photographer: Linda Jacobson
Date: October 31, 2011

They then drove to the Pond 2 site where Ms. Jacobson was shown the current status of the Pond 2 closure work. Mr. Denton showed Ms. Jacobson the area where there had formerly been a walkway, submersible pump and concrete sump. The excavation extended below the clay liner in this area, and as Mr. Denton pointed out, the staining below the clay liner appeared to be due to groundwater impacts and was outside the scope of the consent agreement closure activities. The facility plans to install a pump to stop groundwater from flowing into the former Pond 2.

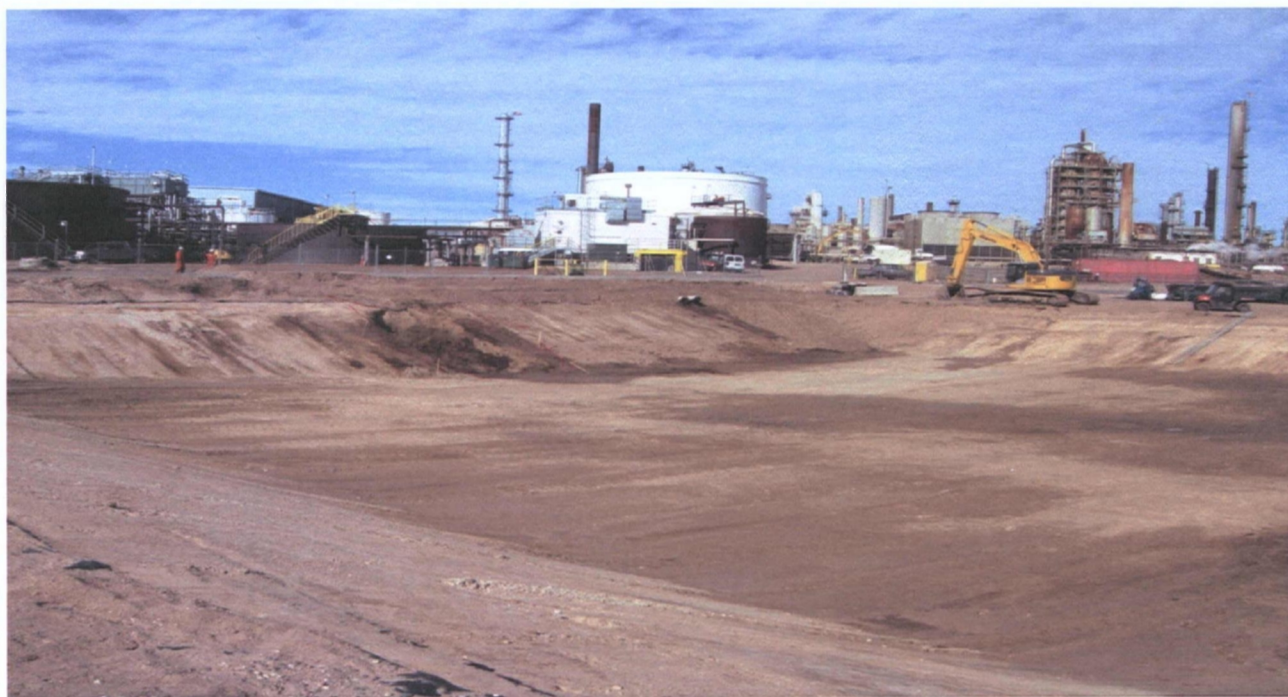
Photo: 15
Facility: Frontier Refining
Subject: Clay Liner with Plugged
Inlet Pipes
Photographer: Linda Jacobson
Date: October 31, 2011

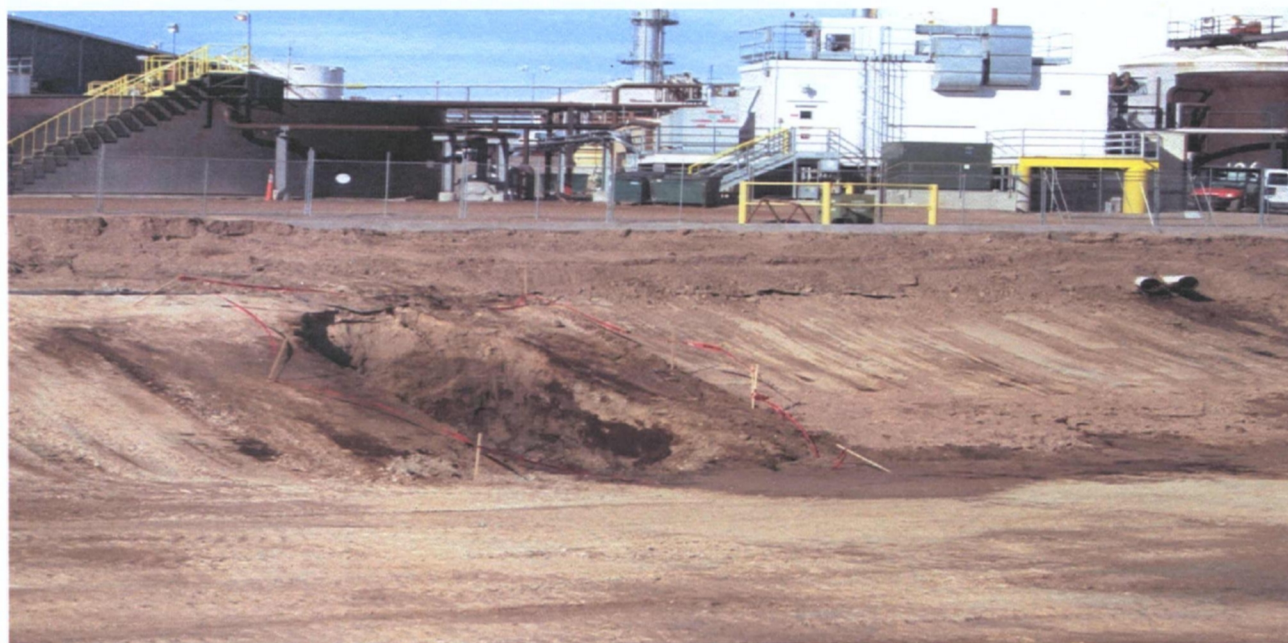
Photo: 16
Facility: Frontier Refining
Subject: Status of Pond 2 Work
Photographer: Linda Jacobson
Date: October 31, 2011

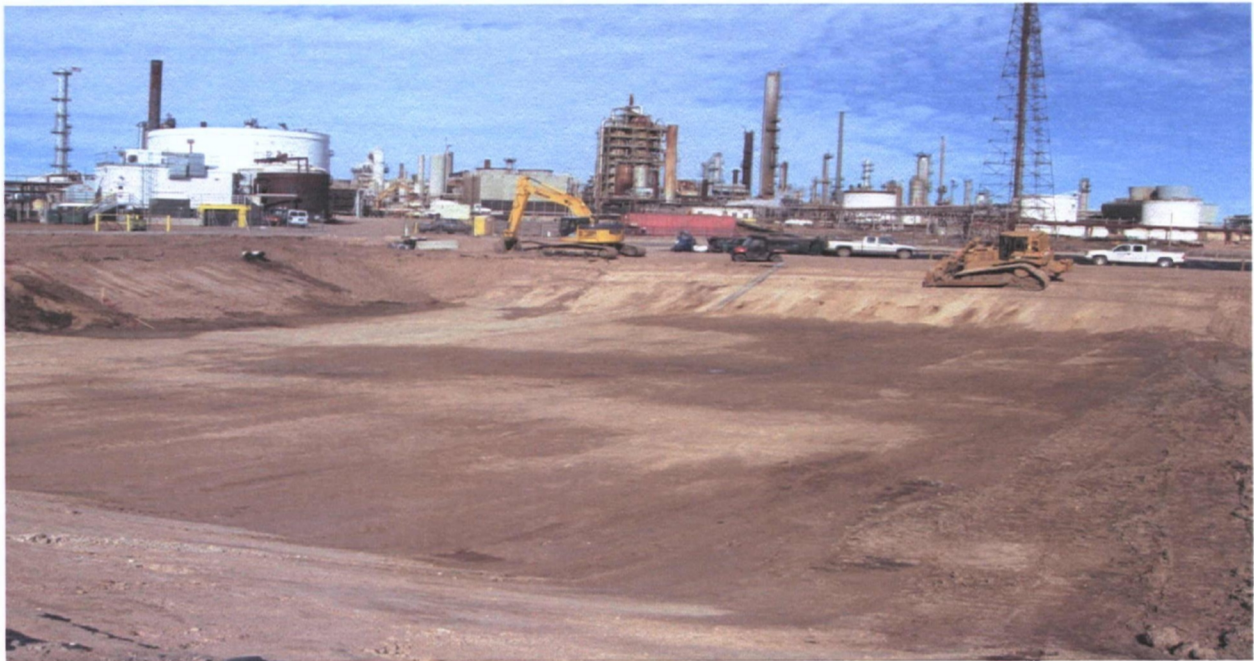
Photo: 17

**Subject: Clay Liner Slightly
Moist from Recent Precipitation**

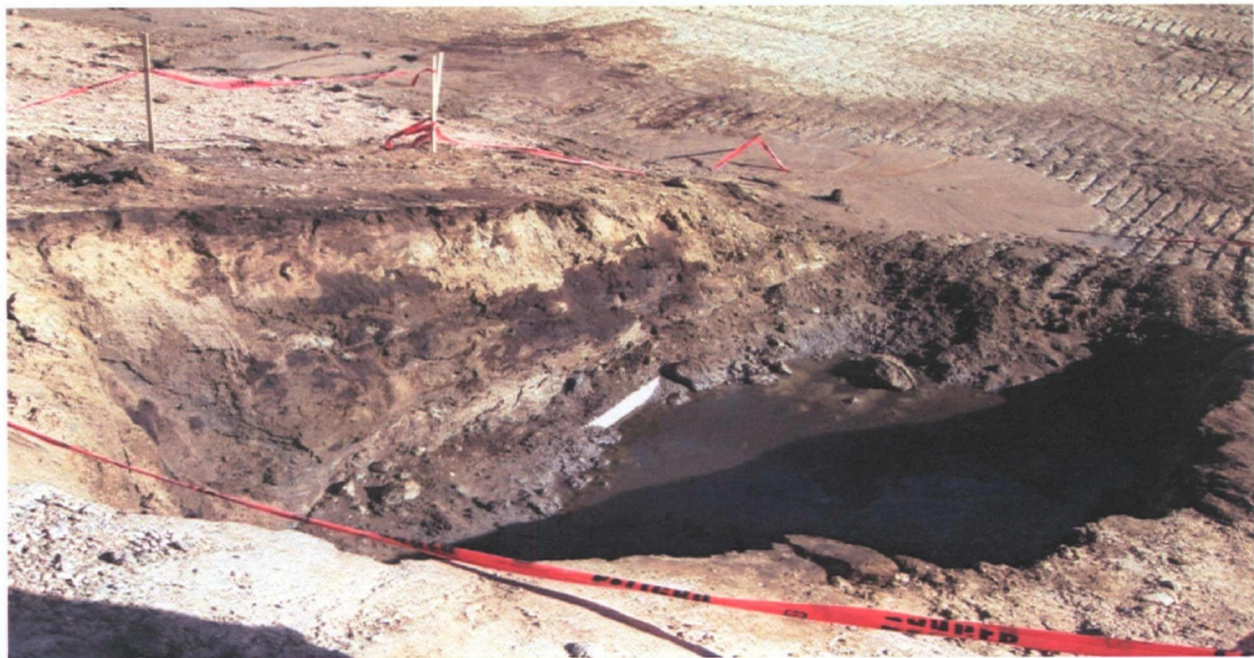
Photo: 18

**Subject: Area to Be Further
Remediated, Note Groundwater
Intrusion**

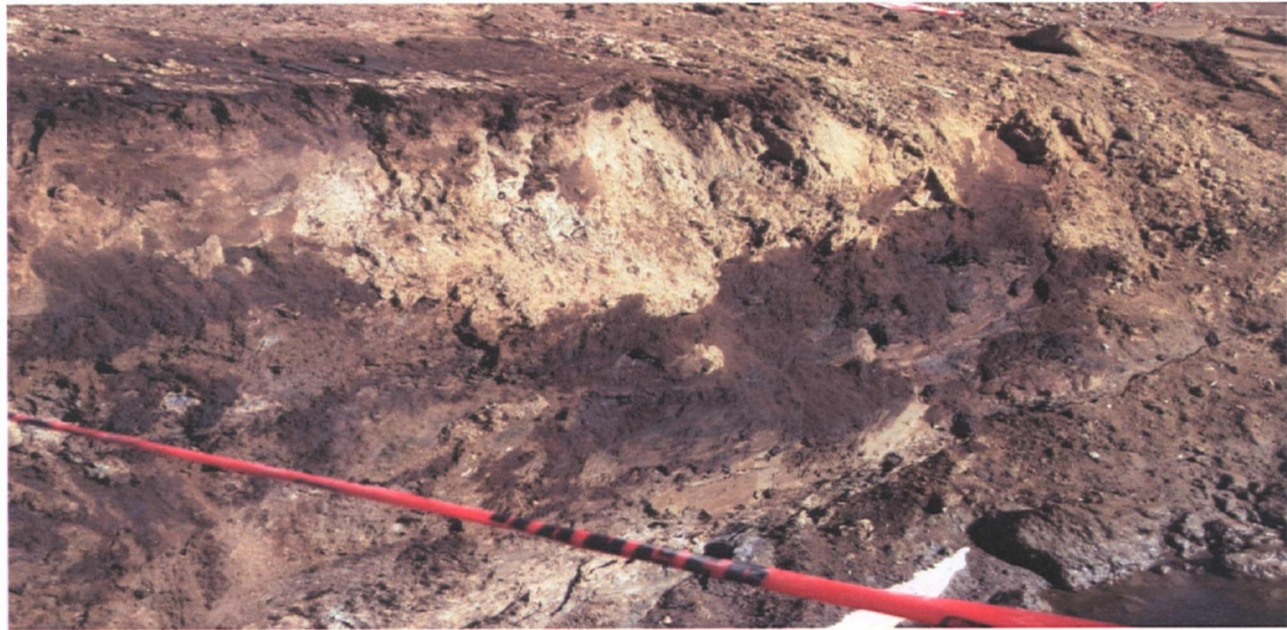
Photo: 19
Facility: Frontier Refining
Subject: Staining to Be Further
Addressed
Photographer: Linda Jacobson
Date: October 31, 2011

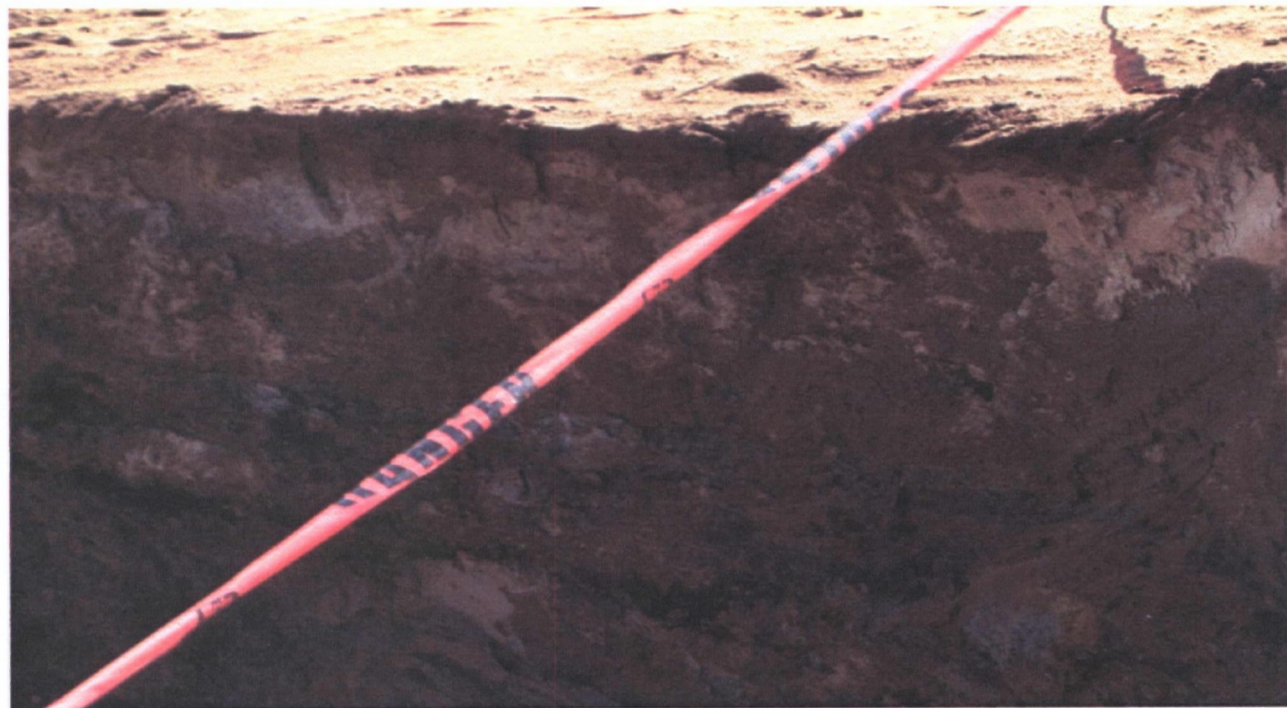
Photo: 20
Facility: Frontier Refining
Subject: Staining to Be Further
Addressed
Photographer: Linda Jacobson
Date: October 31, 2011

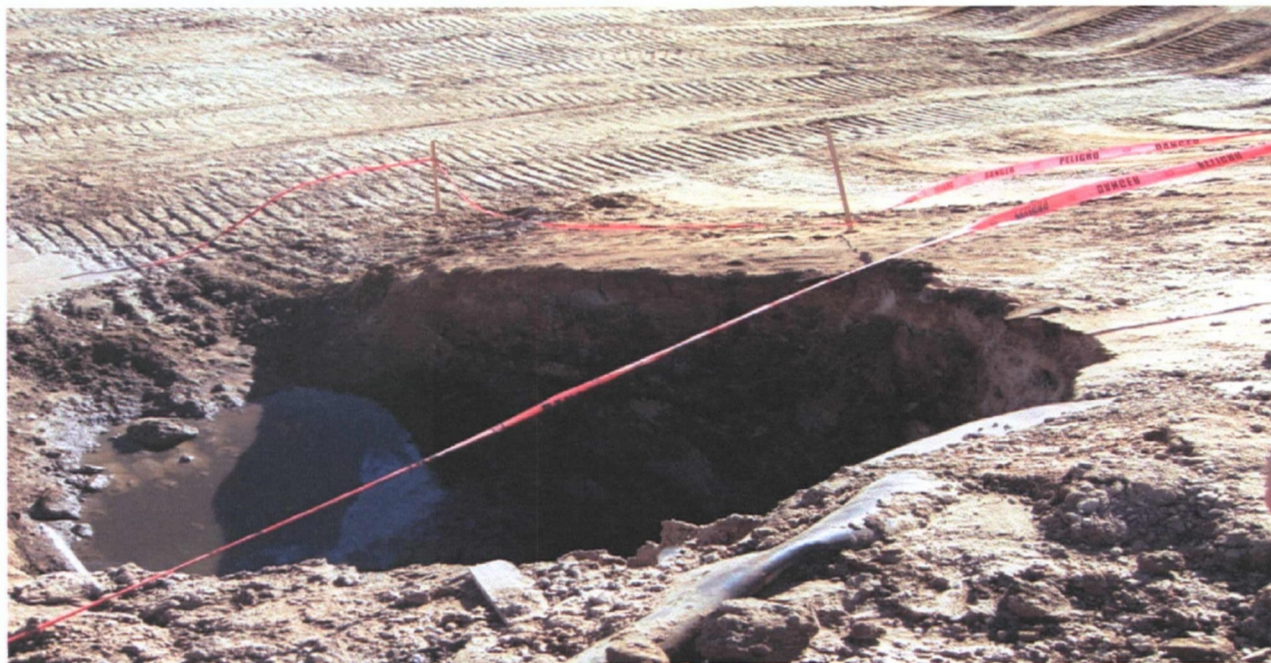
Photo: 21
Facility: Frontier Refining
Subject: Layers of Stained Soil
on Side to Be Remediated as
Part of Closure Work
Photographer: Linda Jacobson
Date: October 31, 2011

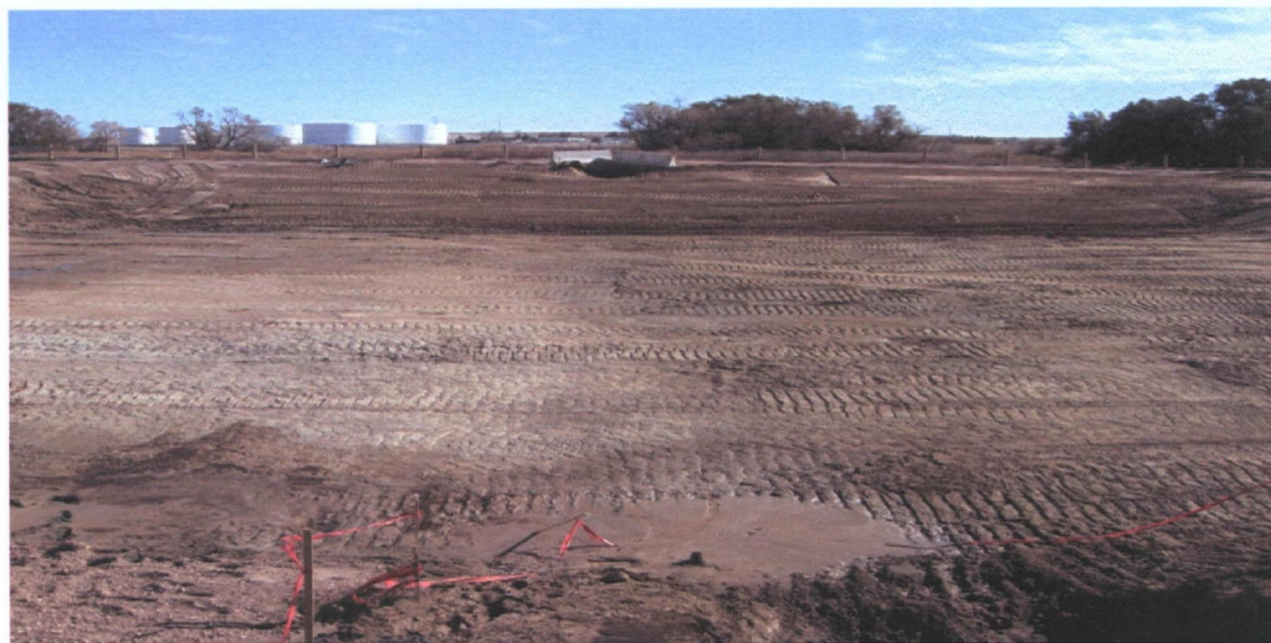
Photo: 22
Facility: Frontier Refining
Subject: Pond 2 Clay Liner after
Stained Clay, Liner and Geofabric
Removal
Photographer: Linda Jacobson
Date: October 31, 2011

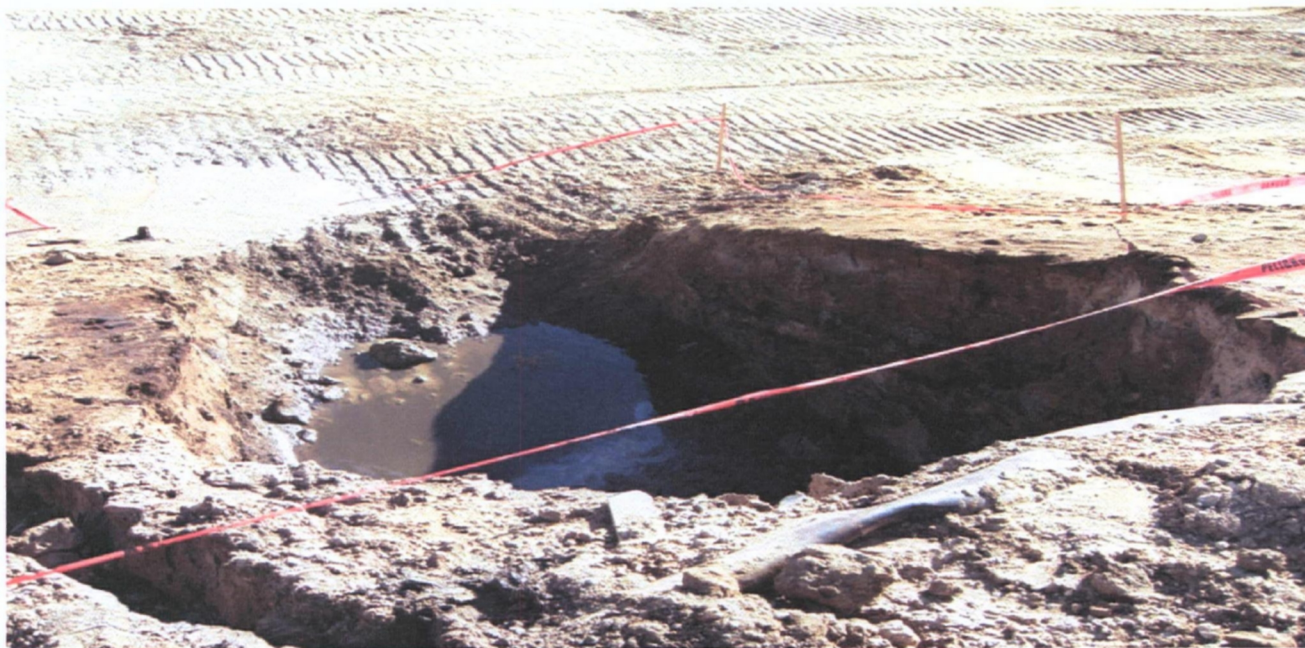
Photo: 23
Facility: Frontier Refining
Subject: Area of Pond Requiring
Further Remediation
Photographer: Linda Jacobson
Date: October 31, 2011

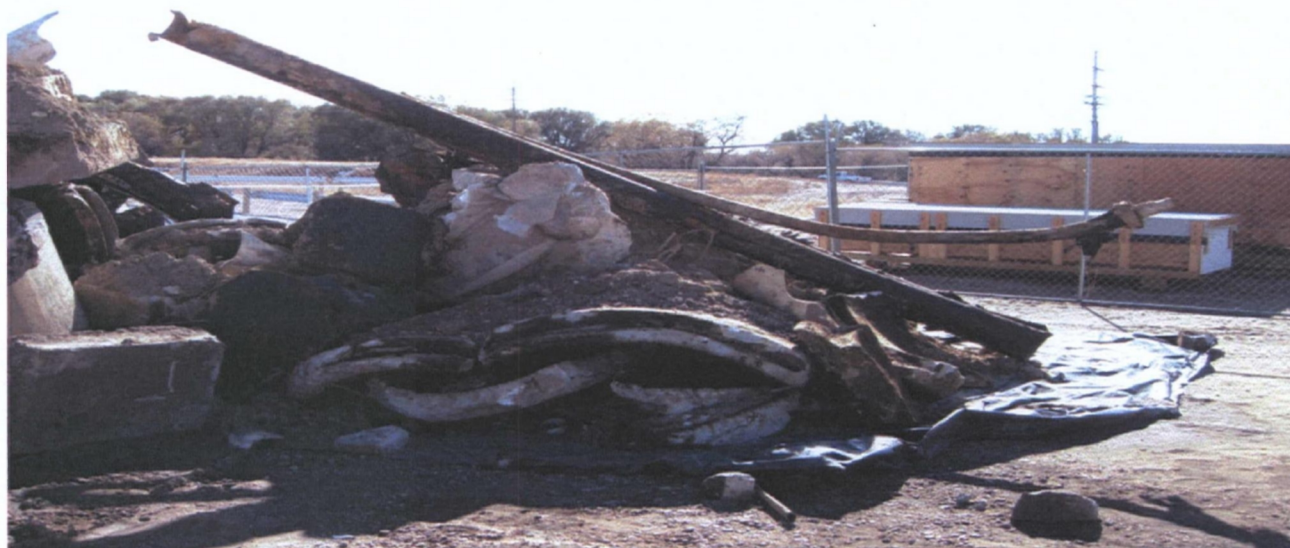
Photo: 24
Facility: Frontier Refining
Subject: Materials Removed from
Pond 2
Photographer: Linda Jacobson
Date: October 31, 2011

Ms. Jacobson was shown the materials removed from the pond. The oil-contaminated concrete will be sent to a non-hazardous landfill. The soft-top rolloffs contained the Pond 2 synthetic liner and were labeled as "Pond 2 Liner Pending Analysis 10/20/11". There were three hard top roll-offs which were labeled as "Pond 2 Sludge Pending Analysis 10/24/11". These three roll-offs contained the geofabric as well as the stained sand and soils removed from between the synthetic and clay liners.

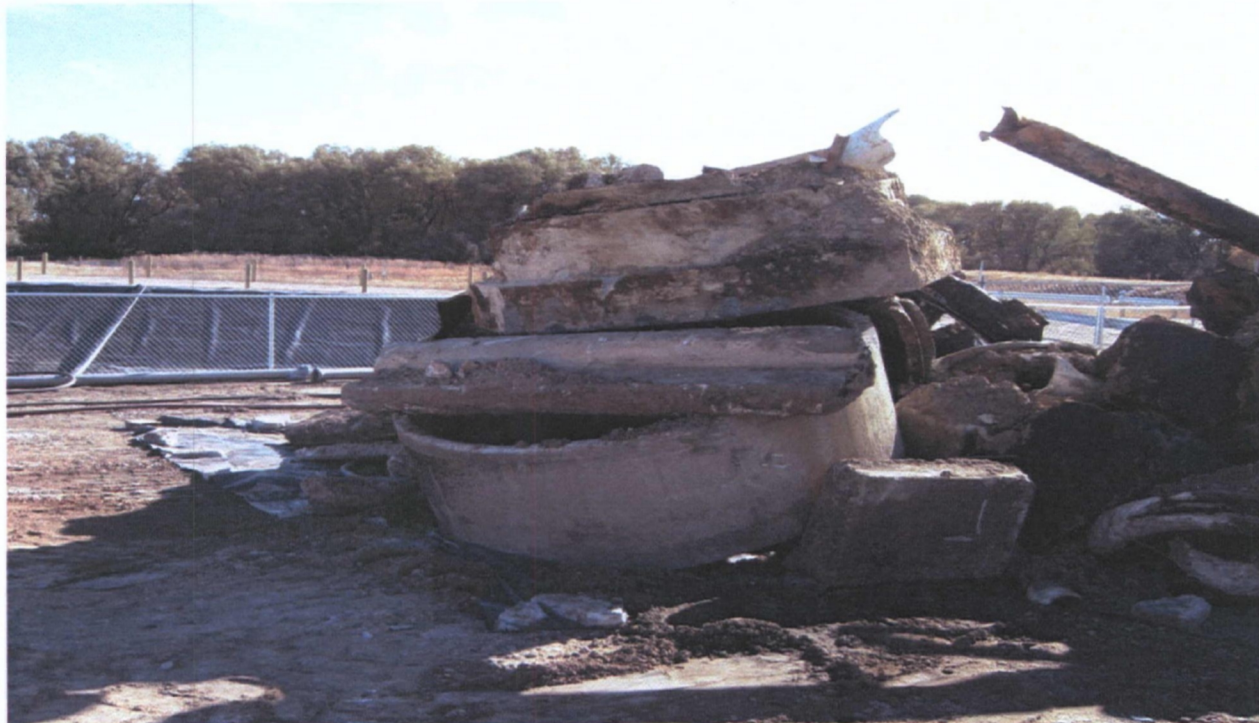
Photo: 25

**Subject: Concrete Removed from
Pond 2**

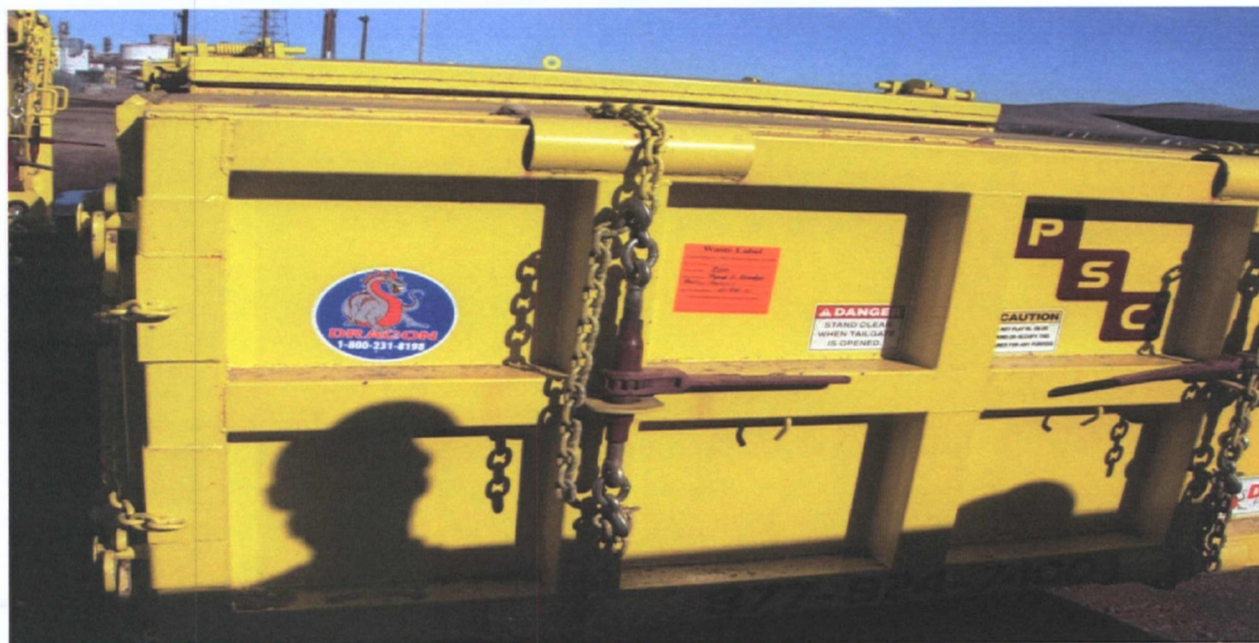
Photo: 26

**Subject: Sealed Roll-off
Containing Pond 2 Wastes**
